NSTIC TRANSLATION NO 1305

THE PROBLEMS OF PITTING IN AUSTENITIC CR-NI-STEELS

H. GRAFEN

Metalloberflache 13 No 6 (June 1959) pp 161-166

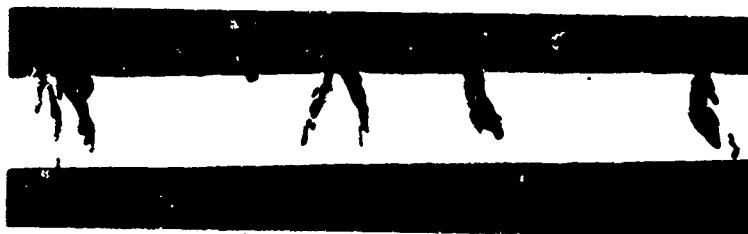
Bild 13. Querschnittsaufnahme zu Bild 12

FIGURE 13 Sectional view of the sample in Figure 12.
